THAMES RIVER BASIN
THOMPSON, CONNECTICUT

NORTH GROSVENORDALE POND DAM

CT 00183

**PHASE I INSPECTION REPORT
NATIONAL DAM INSPECTION PROGRAM**

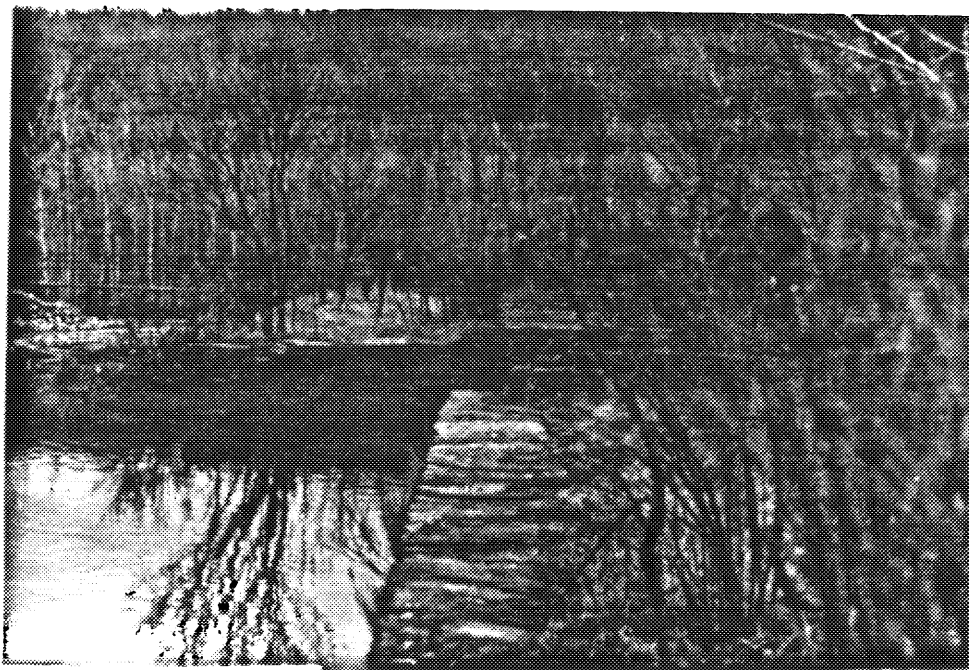
1. View along crest of right abutment

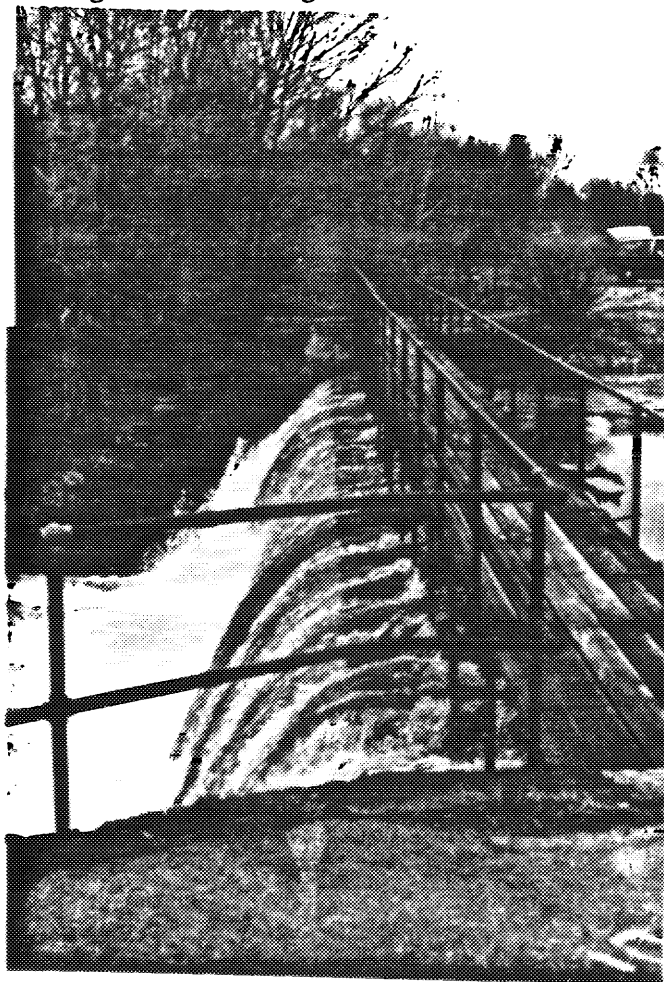
2. Crest of Right Spillway

(3) Inspect the right spillway and sluiceway during periods of low or no flow conditions.

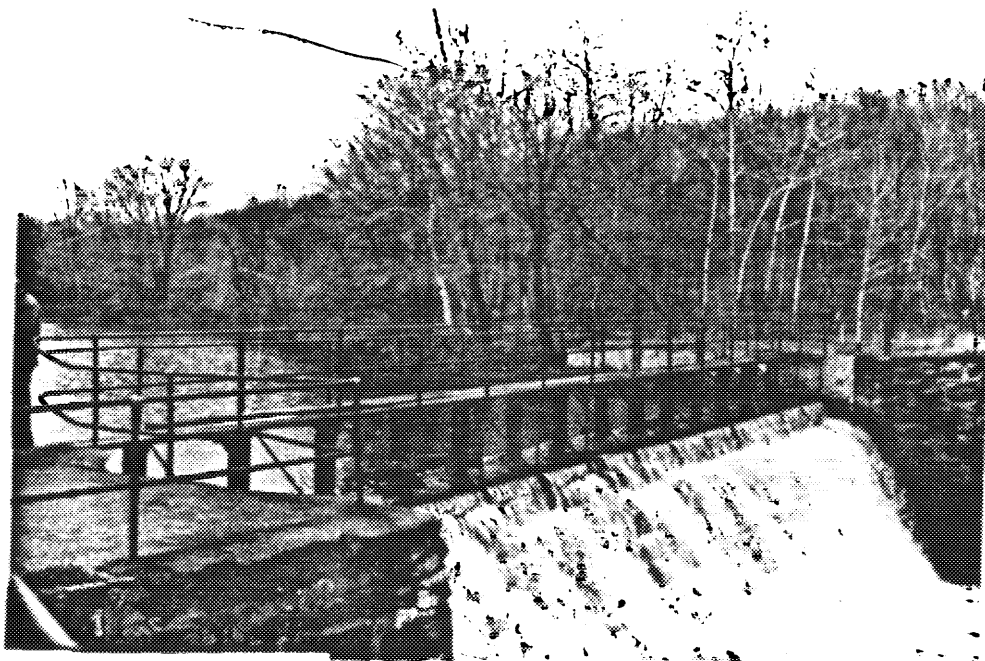
3. Crest of Left Spillway

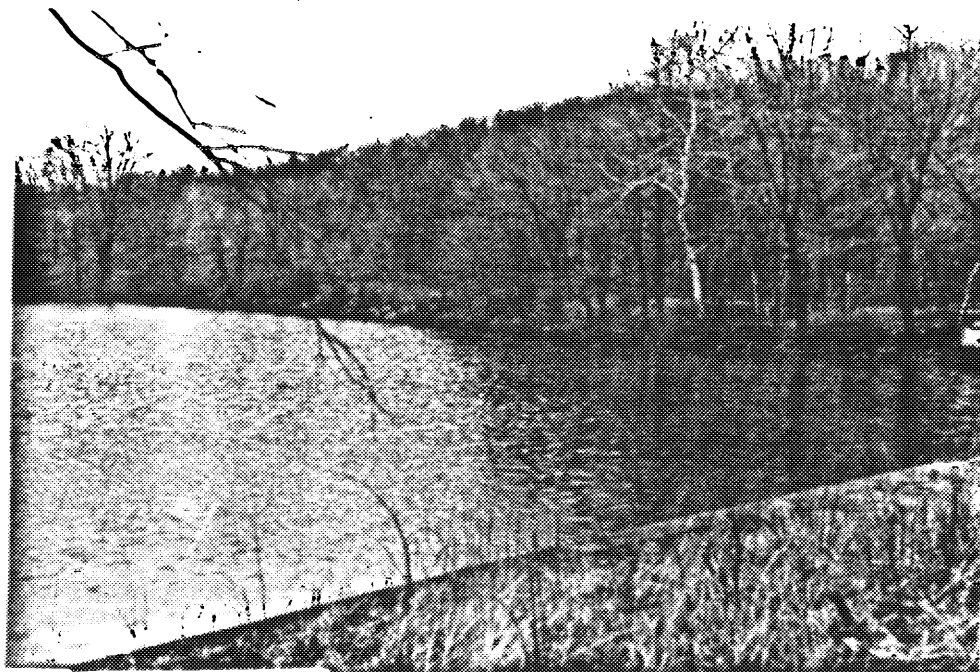
(3) Dike. The general condition of the earth dike appears to be good with no evidence of potholes, sinkholes or seepage. However, there is considerable tree growth on the dike, both on the upstream and downstream slopes as well as on the crest. There is a dry masonry wall extending from the left end of the left spillway to the south end of the dike. This wall serves to retain the end of the earth dike. The wall's stones are square and the alignment is quite good. The Penn Central Railroad is located parallel to and just east of the dike.

4. Upstream Face of Left Abutment Dike

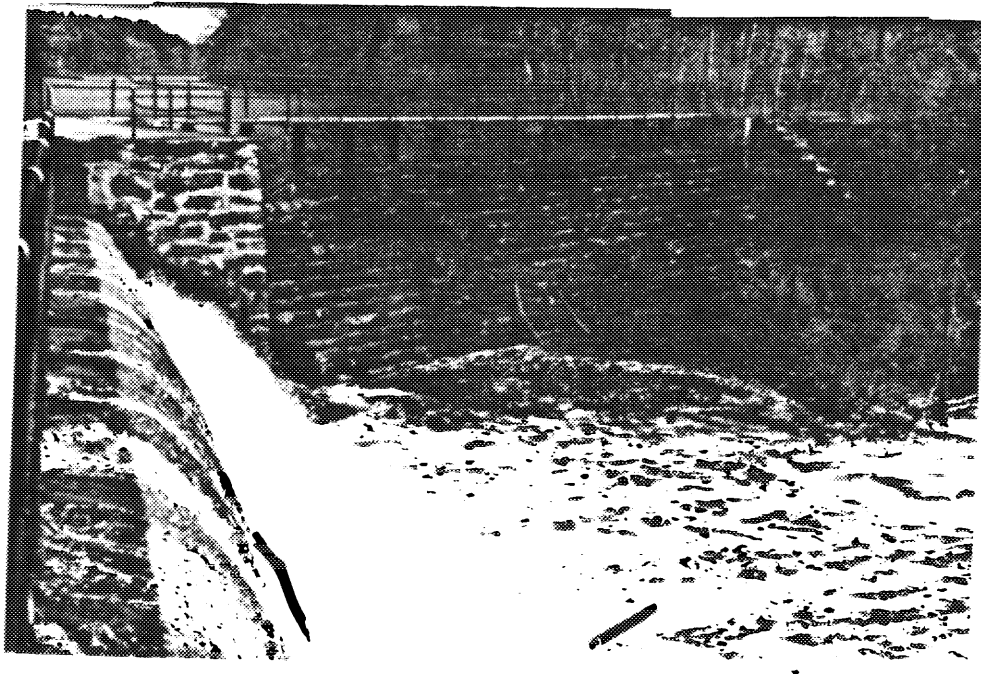
The general condition of the ashlar stones in the face of the spillways is fair. Some of the stones in the left spillway are not square and show signs of deterioration and displacement. (See Photo Nos. 5 and 6, Appendix C) There is an old sluiceway opening at the base of the right end of the left spillway which extends into the reservoir and was discharging water. The invert is estimated to be at elevation 353(±) MSL.

5. Stepped Downstream Face of Left Spillway

(4) Determine whether repairs are needed along the downstream face of the spillways and in the riverbed at the toe of the dam.

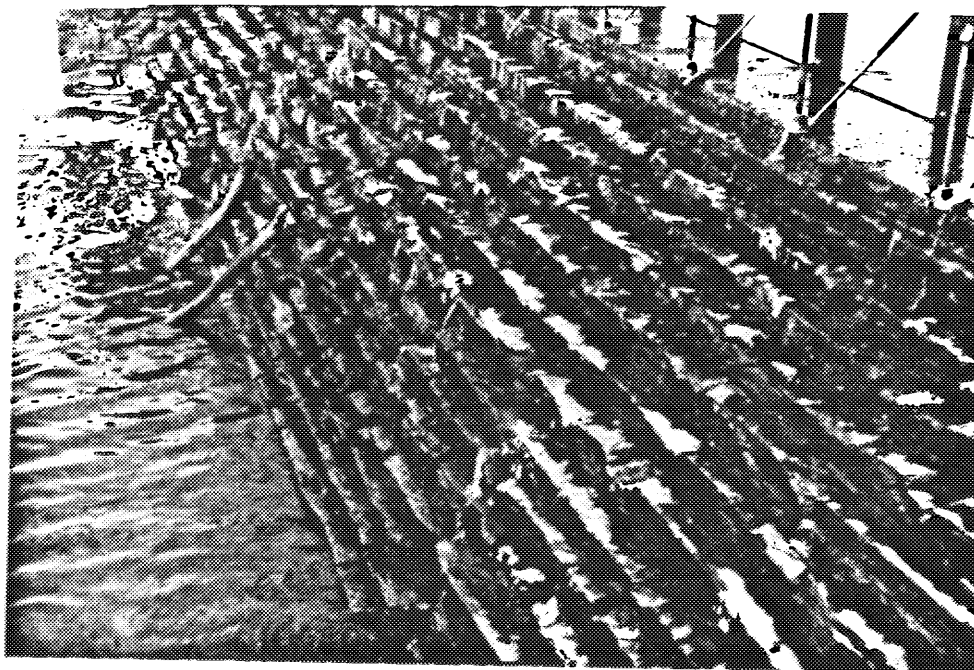
(3) Some of the ashlar masonry blocks on the downstream face of the left spillway have been displaced. The ashlar face on the downstream side of the right spillway and the condition of the plunge pools below the dam could not be seen at the time of the inspection owing to the high flow.

6. Stepped Downstream Face of Left Spillway Showing Missing and Deteriorated Stones.

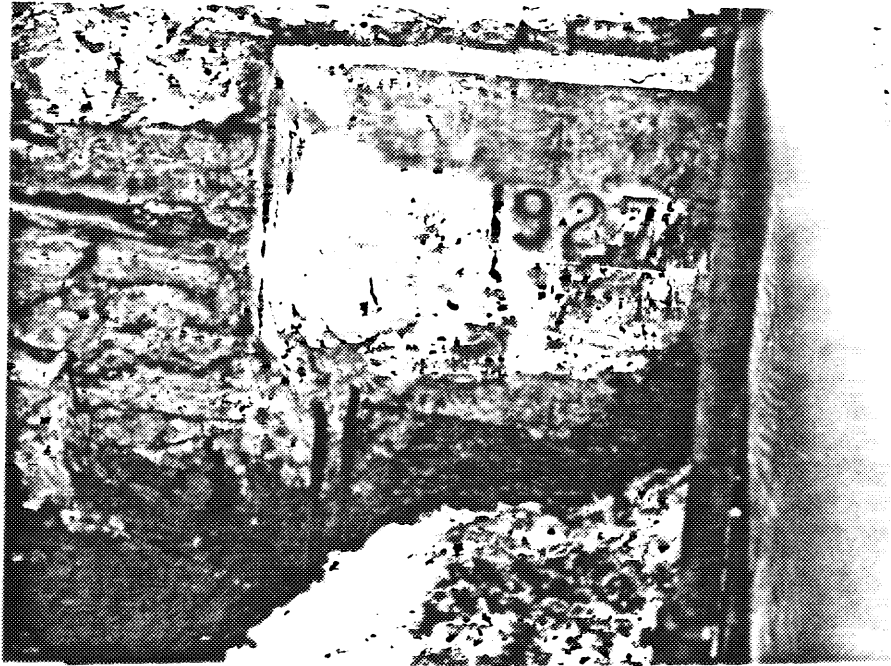
Some items of minor structural distress were noted. The right training wall of the right spillway shows some loss of mortar in the joints. There is minor spalling and cavitation of the concrete wall on the upstream side on both the left and right sides of the right spillway. (See Photo Nos. 7 and 8 Appendix C.) Photograph No. 9, Appendix C shows the downstream end of the masonry wall which retains the island separating the two spillways. It should be noted that there is a tree growing on the face of the wall and that mortar is missing from the joints, particularly near the base of the wall.

7. Cavitation and Erosion in Concrete Overlay of
West Training Wall, Right Spillway

- (1) Repair deteriorated concrete on the west abutment.
- (2) Point masonry walls with mortar in the right training wall of the right spillway, the masonry wall at the junction of the two spillways and other masonry walls.
- (3) Repair bridges over the spillways by installing new planking and adequate support.
- (4) Remove tree from masonry wall on center island.
- (5) Stoplogs should not be installed until all the above recommendations and all other remedial measures have been implemented;
- (6) Develop a formal flood warning plan to follow in the event of an emergency, including round-the-clock monitoring during heavy precipitation.
- (7) Institute procedures for an annual periodic technical inspection of the dam and its appurtenant structures.

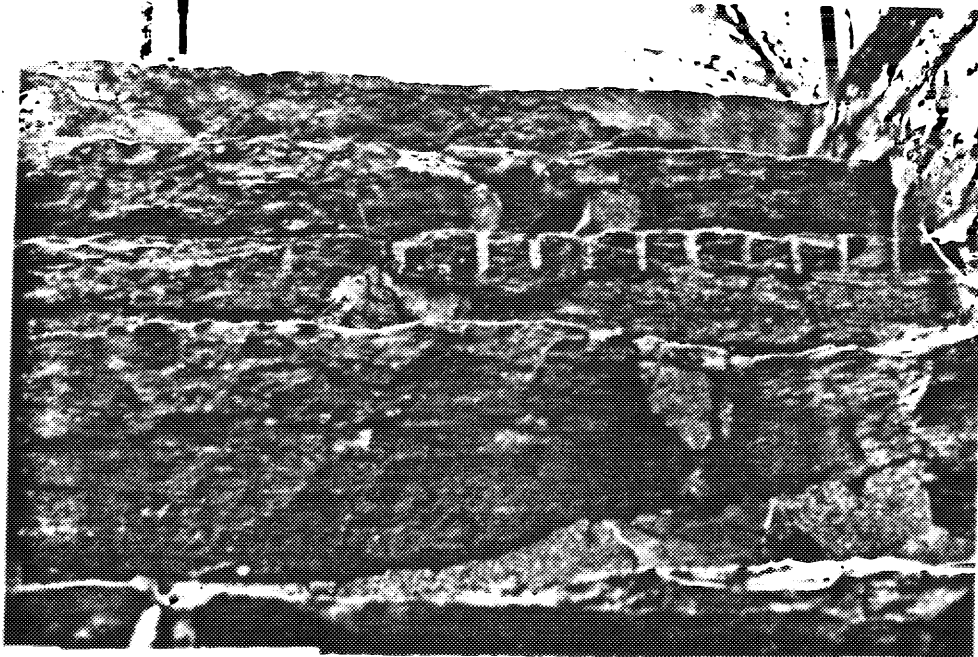
8. Missing Mortar in Joints of Masonry Training Wall
East End of East Spillway

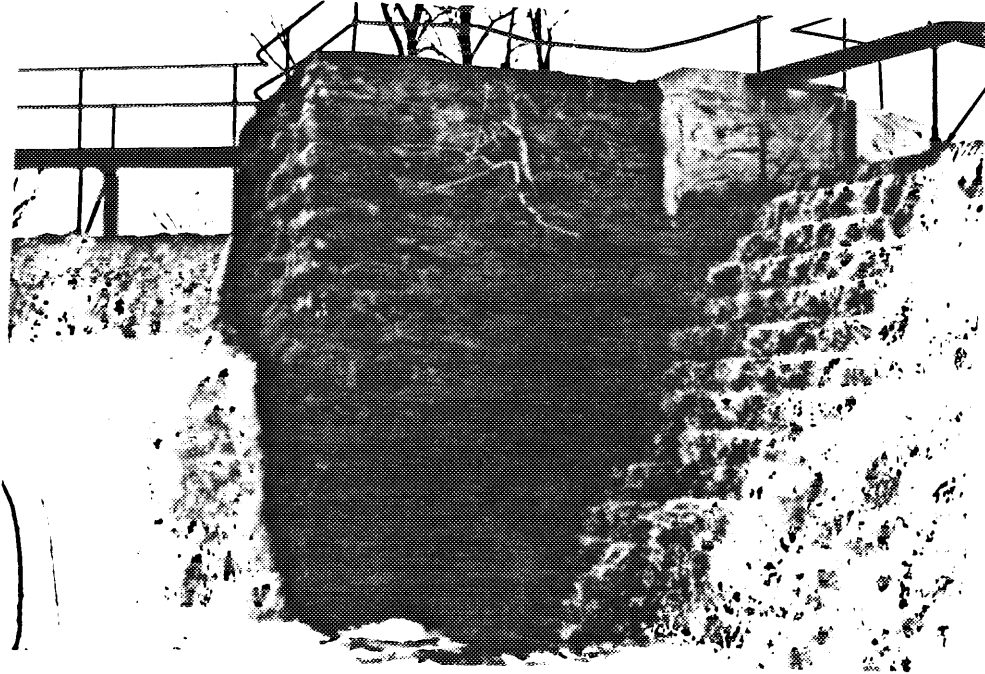
9. Masonry Wall Intersection of East and West Spillways Showing Eroded Mortar in Lower Joints and Tree Growing on Face of Wall.

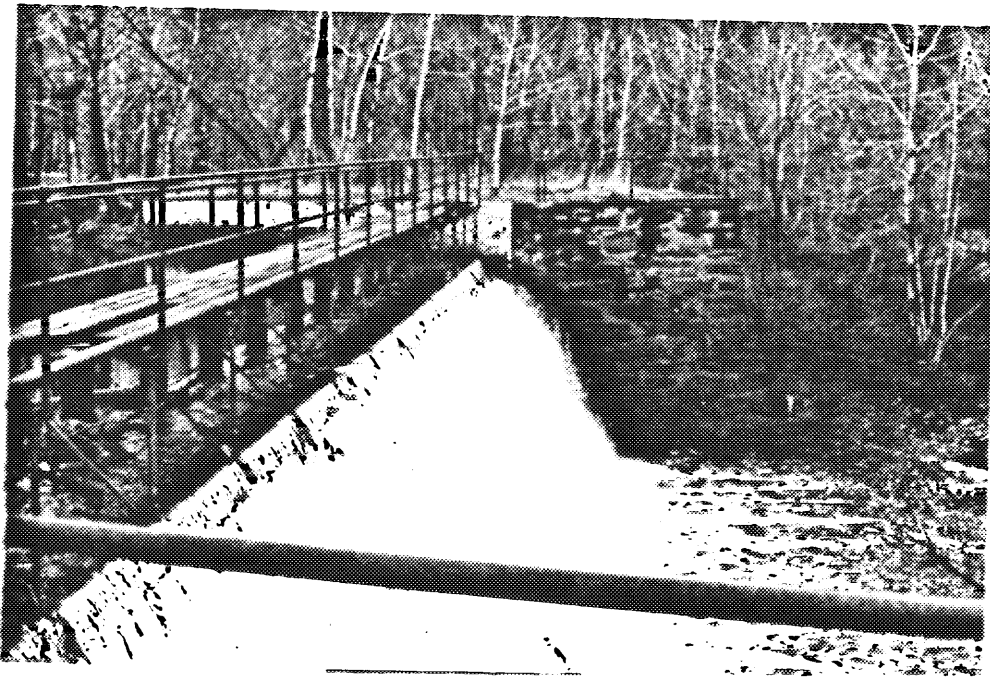
The bridges over the two spillways are in a deteriorating condition. Several of the planks forming the walkway have been destroyed by vandalism. (See Photo No. 10, Appendix C.)

10. Planks Missing from Bridges over Spillways.

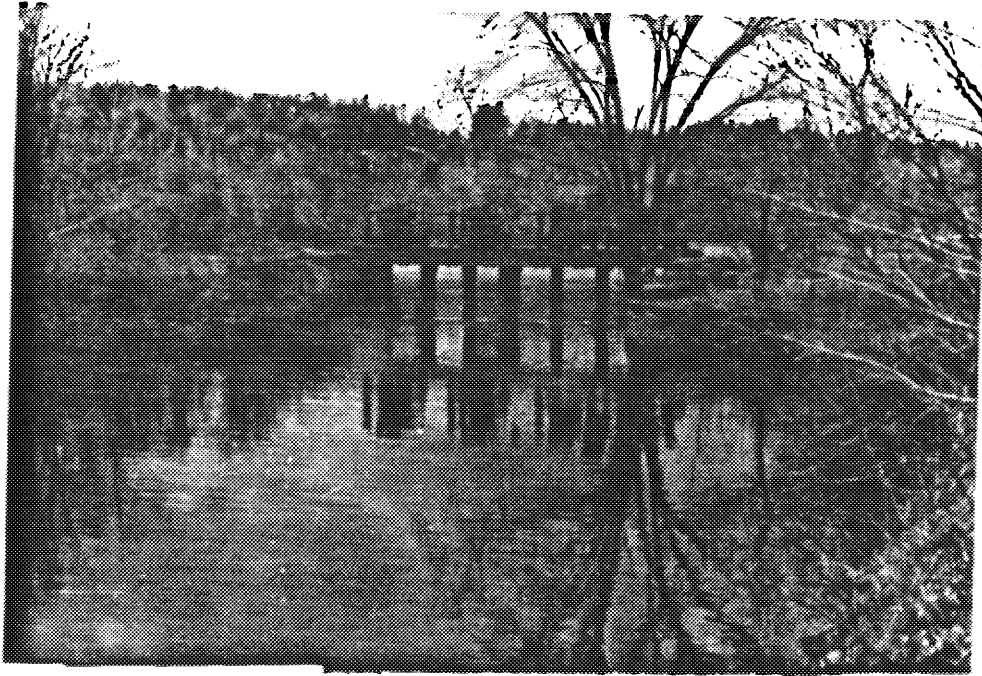
11. Diversion Channel and Gate Structure

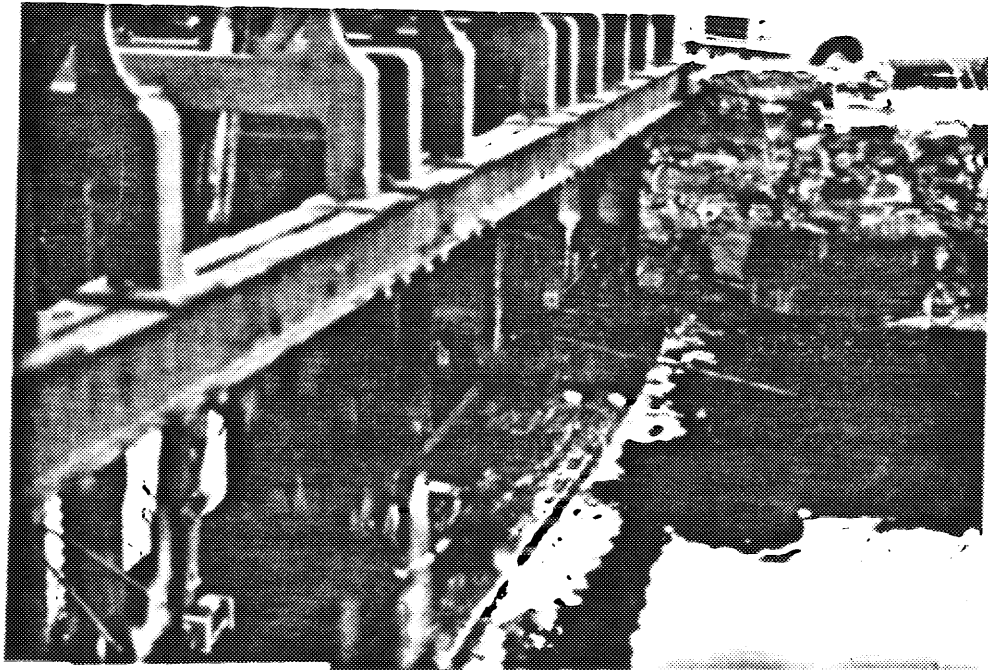
condition having been partially destroyed by fire and are not presently operative. (See Photo Nos. 11 and 12, Appendix C.) The invert elevation of the gates is estimated to be 365(±) MSL. Downstream of the gates outflows through the diversion canal are limited by the hydraulic opening through the mill building.

12. Deteriorated and Inoperable Gates at Diversion Channel

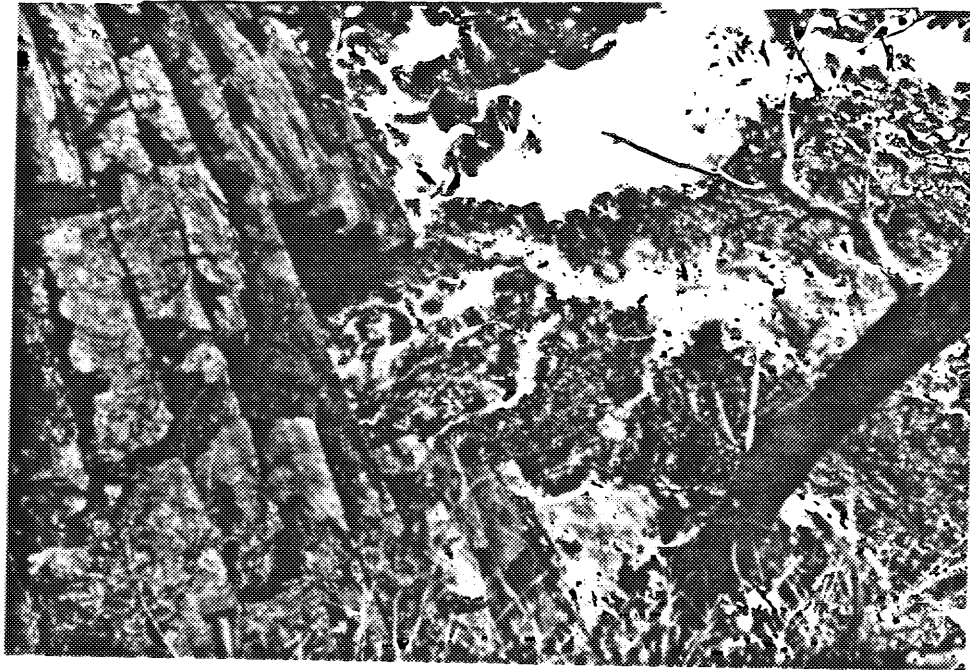
Just upstream in this vicinity, there is a sandbagged area where a small whirlpool measuring about 1 ft. in diameter was noted. The sandbagged area is the remnants of an unsuccessful attempt by the owner to repair the sluice gate. The control mechanism for the sluiceway is missing and it is assumed that the original gate is either missing, or wholly or partially open. The face of the right spillway could not be observed closely owing to the water cascading down the steps. (See Photo No. 13, Appendix C.)

(2) The inoperative condition of the sluice located on the right end of the left spillway and the presence of a whirlpool just upstream of the sluice.

13. Sluice Outlet Through Left Spillway
